# APPENDIX F

## RUNWAY SAFETY ACTION PLAN

**Charles M. Schulz/Sonoma County Airport  
Runway Safety Action Plan  
March 24, 2010**

On March 24, 2010, the FAA Runway Safety Field Operations Group, Western-Pacific Region (AJS-4WP), visited Charles M. Schulz/Sonoma County Airport (STS) in Santa Rosa, California. During the visit, the team met with airport management, airfield operations, air traffic management, and airport users for the purpose of updating the existing Runway Safety Action Plan (RSAP) for the airport. Initially, the Runway Safety Action Team (RSAT) conducted an evening pilot meeting and gathered local pilot observations and recommendations concerning airport surface safety. On the following day, the RSAT team toured the airport to view the airfield (NACO airport diagram appended to end of document). STS has over 300 based general aviation aircraft including jets, helicopters, and gliders. The airport handles in excess of 3,000 air carrier operations per year, and is estimated to handle about 109,833 total operations annually, with an FAA Air Traffic Control Tower in operation daily from 0700 to 2000 PST. The airport's overall safety design planning group goals (Air

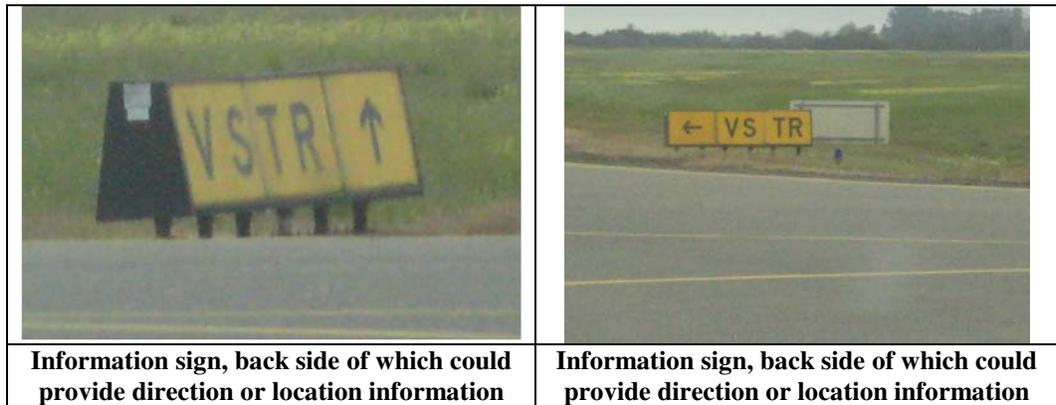
- 3) Recommend that Taxiway Y be more clearly identified with aboveground signage. The RSAT Team noted the fronts and the backs of four “VSTR” signs along Taxiway Y that could be utilized to provide location or directional information (see pictures below). Taxiway Y is predominantly marked by exit signs that are typically difficult for pilots to read.

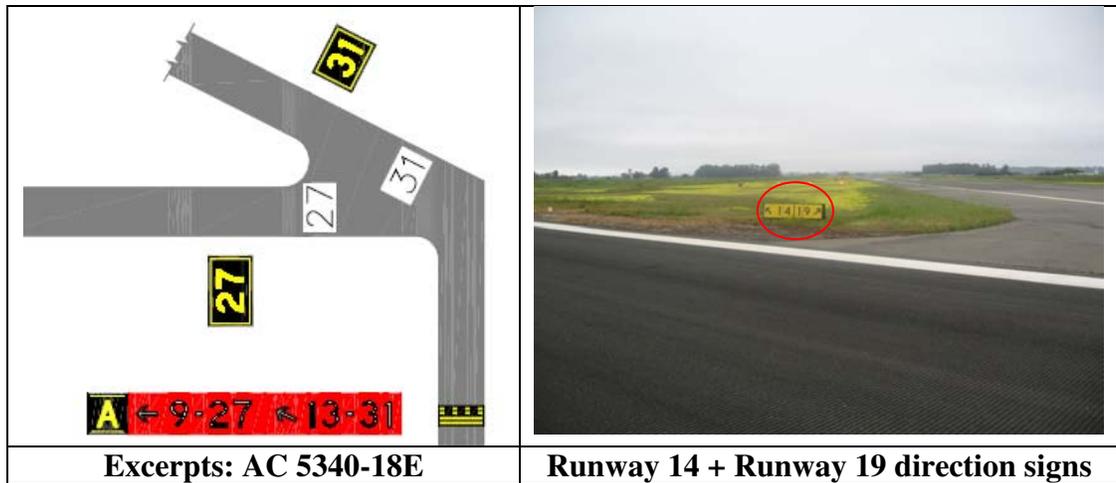
- 7) A black on yellow direction sign at the apex of Runway 14 and Runway 19 (photo below) may be inappropriate or non-standard due to its location in the Runway Safety Area (RSA), with the absence of any mandatory sign for Runway 1/19. Recommend the airport review the sign type, placement, and location with its Certification Safety Inspector. The RSAT Team recommends that the airport request to have its sign plan reviewed and approved for its ACM, with the photo

below (left) providing an example of standard signage for this area. Please note the runway location signs, which the RSAT Team feels are crucial for the prevention of wrong-runway departures.

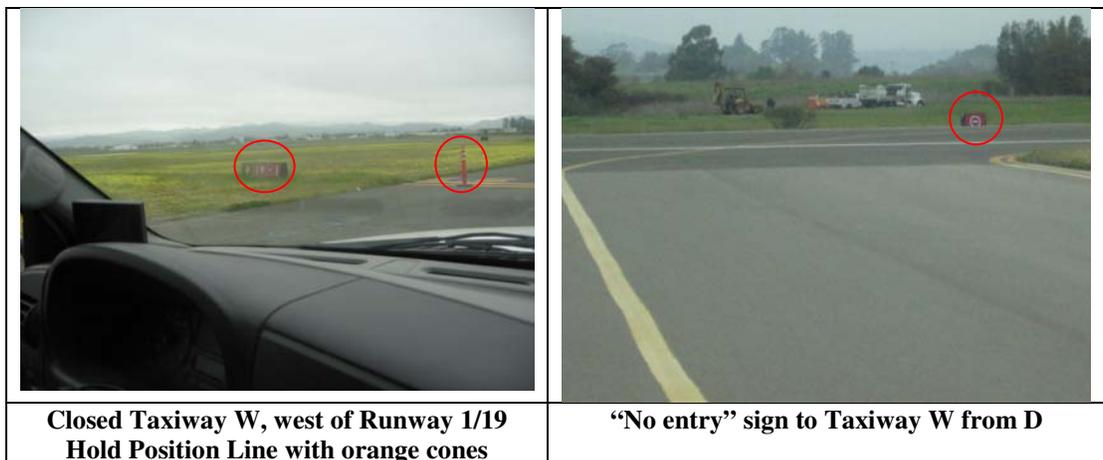
- 8) An area in the AOA marked with a white-on-red “No entry” sign appears to be permanently closed on Taxiway W. Entry from the west side of Runway 1/19 is blocked via orange cones (see pictures below). However, this abandoned area has a Mandatory Runway Holding Position Sign and associated Hold Position Line marking. The markings and signage may partially imply that the area is taxiway available for aircraft use. The airport should consult its Certification Safety Inspector for appropriate signage and marking of this area to prevent any confusion about its availability for normal aircraft use. This may include removing the Runway Holding Position Sign and hold bar markings.

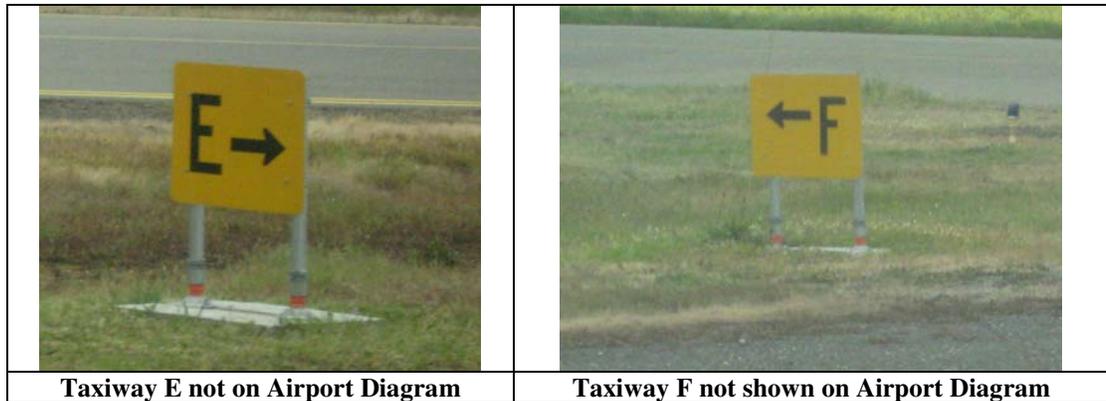
- 9) Taxiway E and F do not appear on the Airport Diagrams published by NACO or Jeppesen. The RSAT Team suggests the airport take action to ensure these taxiways are included on the next cycle of publication for NACO and Jeppesen airport diagrams.

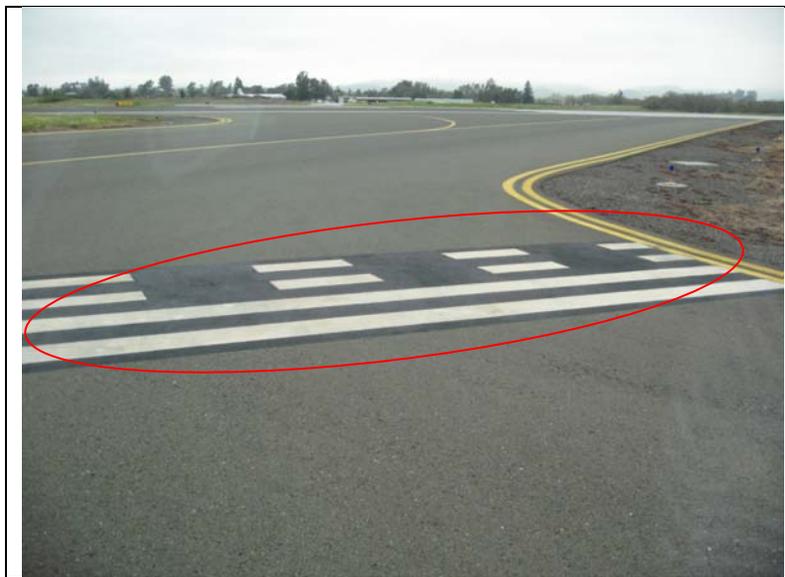
**Observation:** It was noted that the Hold Position Line Markings on Taxiways A and Y east of Runway 14/32 are white (see picture below). Non-standard or discolored hold position line markings may lead to pilot confusion over what might be the associated surface painted markings' true purpose, and may lead to an increased potential for runway incursions.

**Taxiway Y hold position line marking  
should be yellow**

**Action Item:** Recommend the airport paint the hold position line markings on Taxiways A and Y east of Runway 14/32 yellow, with reflective beads, in accordance with FAA AC 150/5340-1J, *Standards for Airport Markings*. Enhanced markings using black highlighting where contrast can be improved is also recommended.

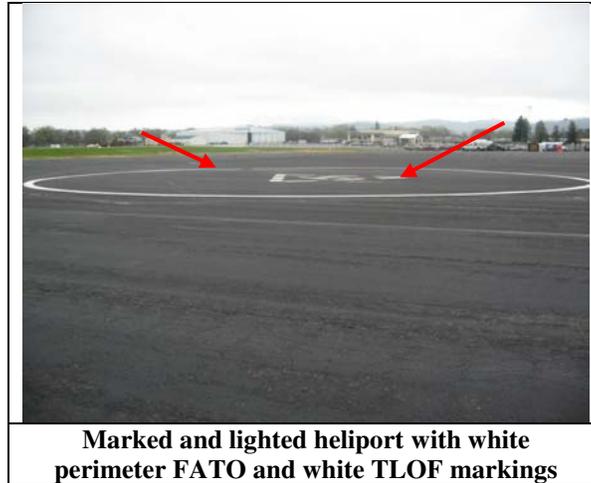
**Observation:** It was noted that a lighted and marked heliport on the airport apron near the intersection of Taxiway Z and Taxiway B is not listed in the Airport Master Record (5010) and has been marked with a white FATO (see picture below). Also noted adjacent to the heliport were several improved helicopter parking pads. The RSAT Team was unable to locate a record or finding related to an airspace determination or established traffic pattern, including approach and departure paths associated with this facility. In this instance, heliport incursions and/or surface incidents may occur where fixed-wing or rotor aircraft simply pass through the white marked area without ATC clearance. The risk to helicopter pilots at night, when the tower is closed, is that they may incorrectly assume that adequate protection from incursions is provided by virtue of the facility’s layout alone.

**Action Item:** The RSAT Team recommends that the airport file FAA Form 7480-1 to formally establish the aeronautical facility (heliport) located near the intersection of Taxiway Z and Taxiway B. The heliport should also be included in the Airport Facility Directory and 5010. Heliports provide at a minimum clear 8:1 approach and departure surfaces, with those imaginary surfaces normally depicted on the ALP. Additionally, the RSAT Team recommends that heliports on airports be located in non-movement areas so the normal ingress and egress of passengers may occur without escort. Finally, properly establishing this new aeronautical facility may require both NEPA and CEQA. Alternatively, the airport may choose to establish a helicopter parking area in place of the current heliport. Helicopter parking facilities are normally marked with yellow perimeters and do not require airspace or approach/departure surfaces. In addition, while heliport lighting is amber, helicopter parking areas have their perimeters delineated with blue lights.
